Figure 12: Gamma Survey Overview Map

NIAGARA FALLS BOULEVARD RADIOLOGICAL SITE  
NIAGARA FALLS, NEW YORK

U.S. ENVIRONMENTAL PROTECTION AGENCY  
REMOVAL SUPPORT TEAM 3  
CONTRACT #EP-S2-14-01

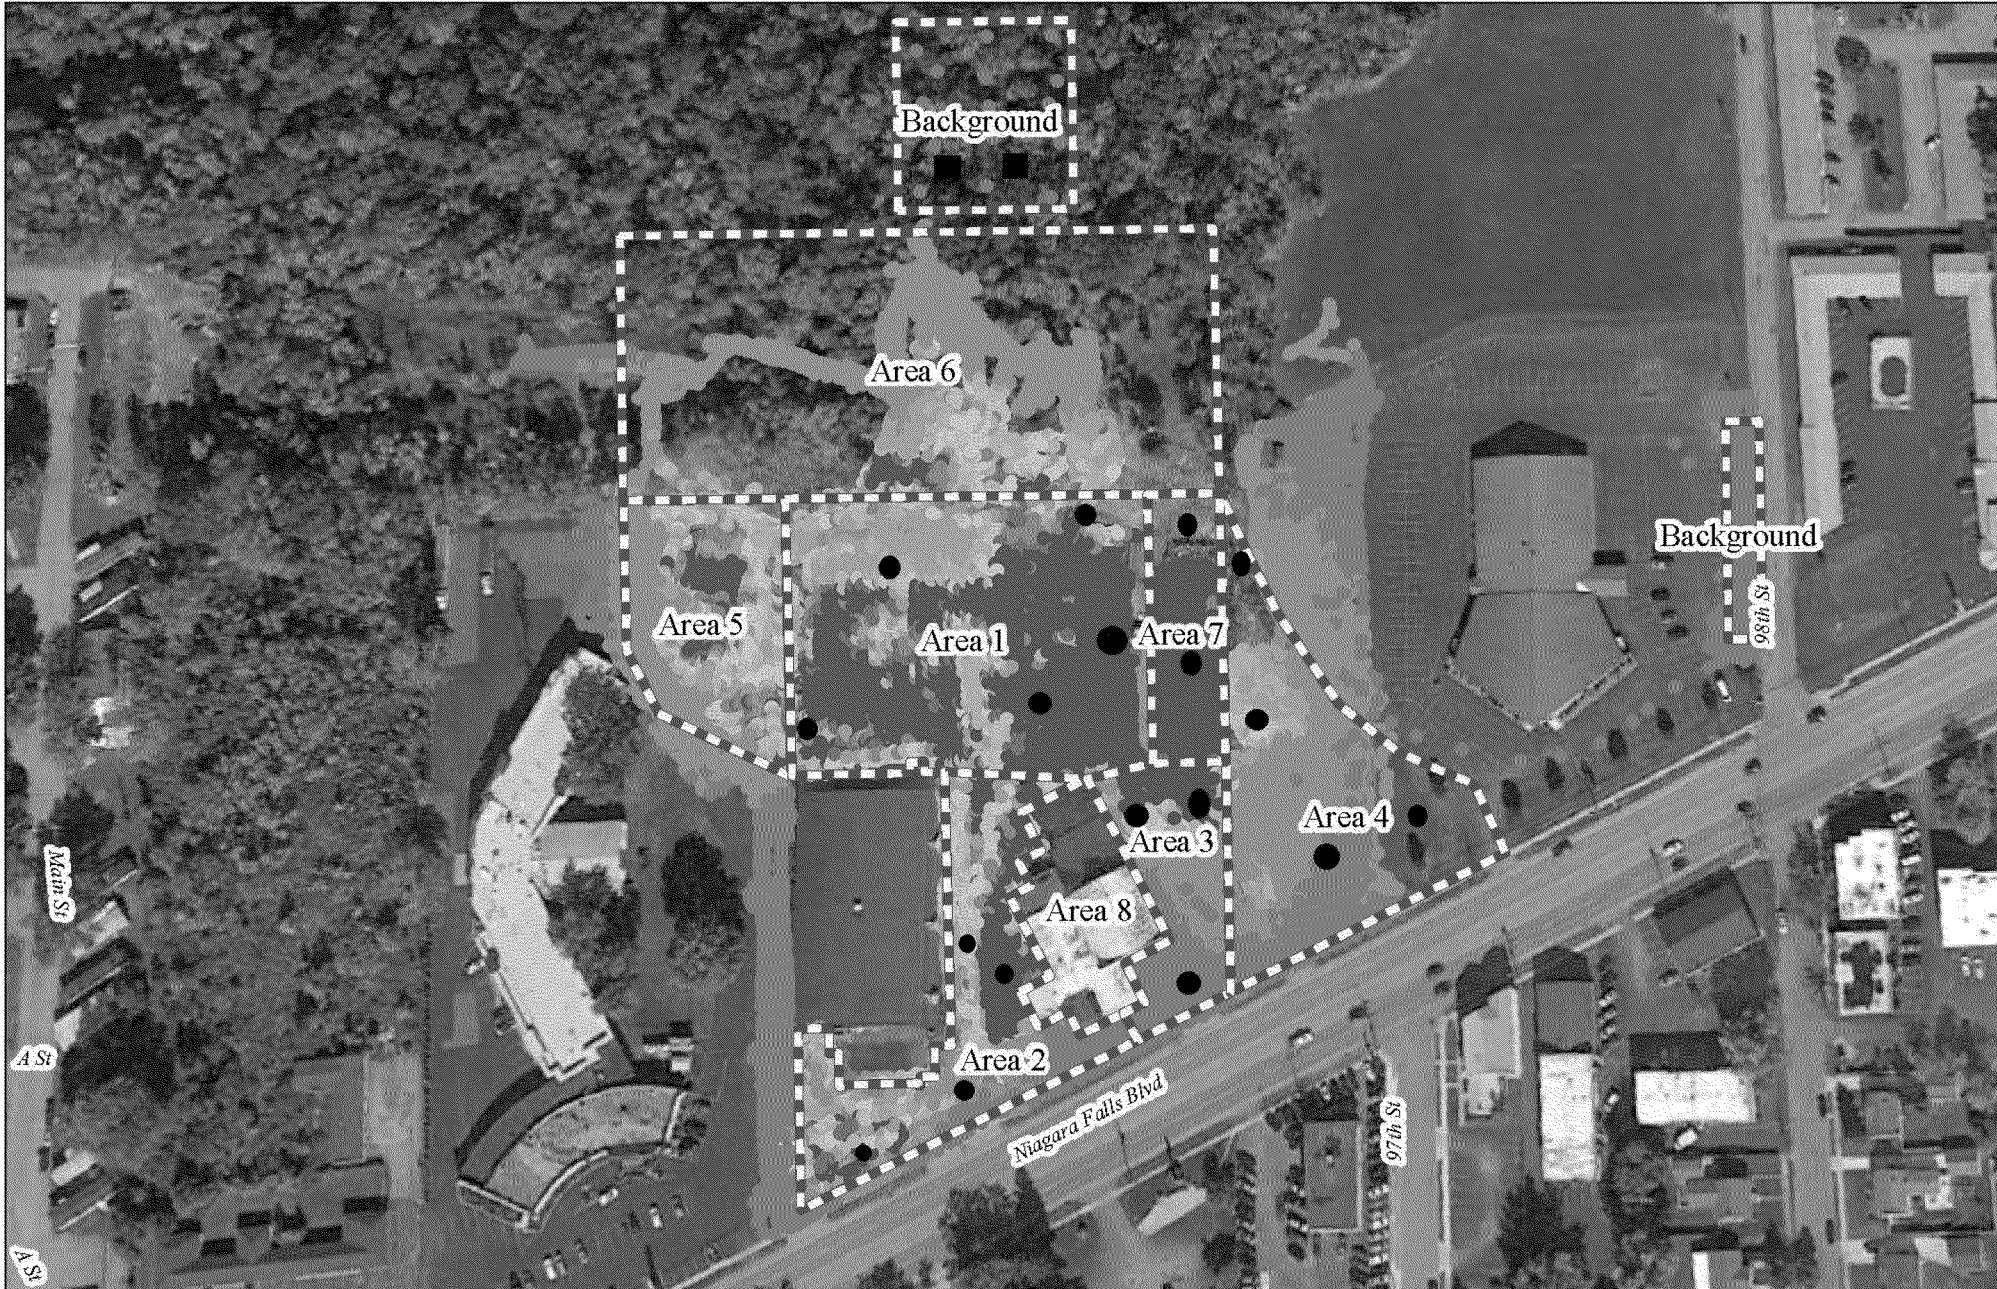
Gamma survey conducted with Ludlum 3x3 Sodium Iodide Detector.  
Gamma survey measurements presenting in micro-Roentgen per hour ( $\mu$ R/hr).  
Background reading: 15  $\mu$ R/hr.
